## Mera -

# 99-7892 INSTALLATION INSTRUCTIONS

CAR	<u>PAGE</u>
ACURA	
CL 1997-99	1
Integra 1990-93	2
Integra 1994-00	
Legend 1990	4
Legend 1991-96	5
TL 1996-98	
Vigor 1992-94	
HONDA	
Accord 1990-93	8
Accord 1994-97	9
Odyssey 1995-98	
ISUZU	
Oasis 1996-99	10

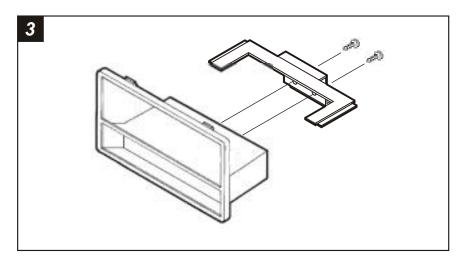
Cut and remove the SIDE clips from the *Radio Housing*.

Mount the *Rear Support Bracket* to the back of the pocket with (2) *Phillips Screws* supplied. Skip to the Installation Instructions for ALL VEHICLES on Page #11.

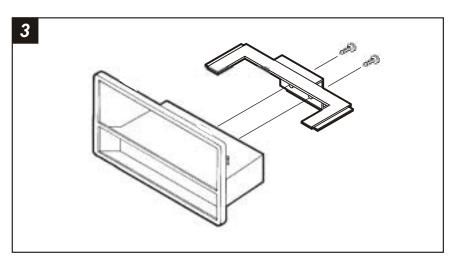
Cut and remove the *TOP* clips from the *Radio Housing*.

<u>ISO-DIN HEAD UNITS:</u> Mount the **Rear Support Bracket** to the back of the pocket with **(2) Phillips Screws** supplied. Skip to the Installation Instructions for ALL VEHICLES on Page #11.

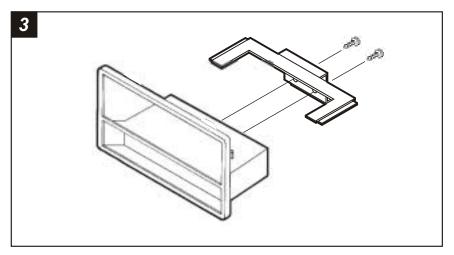
Mount the Rear Support Bracket to the back of the pocket with (2) Phillips Screws supplied. Skip to the Installation Instructions for ALL VEHICLES on Page #11.

ISO-DIN HEAD UNITS: Mount the Rear Support Bracket to the back of the pocket with (2) Phillips Screws supplied. Skip to the Installation Instructions for ALL VEHICLES on Page #11.

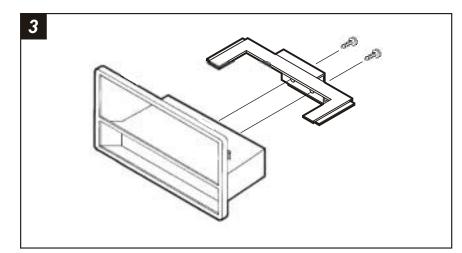
Cut and remove the *TOP* clips from the *Radio Housing*.

<u>ISO-DIN HEAD UNITS:</u> Mount the **Rear Support Bracket** to the back of the pocket with **(2) Phillips Screws** supplied. Skip to the Installation Instructions for ALL VEHICLES on Page #11.

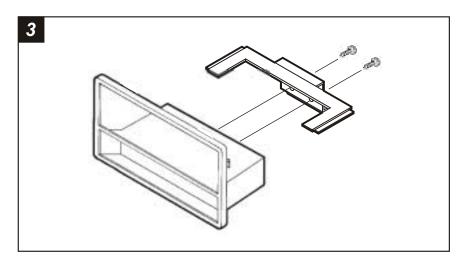
<u>ISO-DIN HEAD UNITS:</u> Mount the **Rear Support Bracket** to the back of the pocket with **(2) Phillips Screws** supplied. Skip to the Installation Instructions for ALL VEHICLES on Page #11.

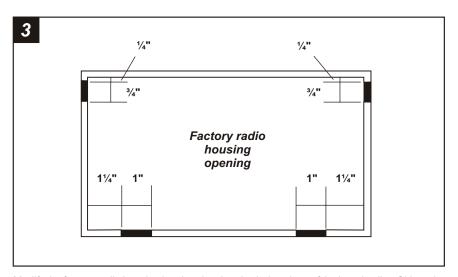
Modify the factory radio housing by trimming the *shaded* portions of the housing lip. *Skip to the Installation Instructions for ALL VEHICLES on Page #11.*

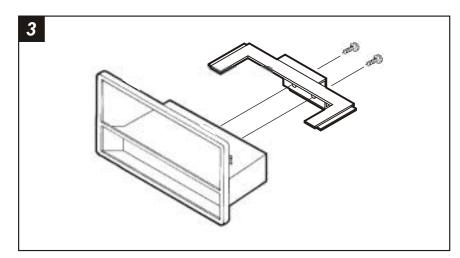
Cut and remove the TOP clips from the  $\it Radio\,Housing.$

<u>ISO-DIN HEAD UNITS:</u> Mount the **Rear Support Bracket** to the back of the pocket with **(2) Phillips Screws** supplied. Skip to the Installation Instructions for ALL VEHICLES on Page #11.

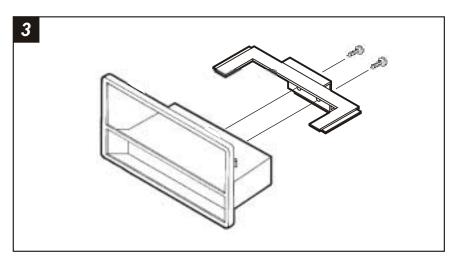
Cut and remove the *TOP* clips from the *Radio Housing.*

<u>ISO-DIN HEAD UNITS:</u> Mount the **Rear Support Bracket** to the back of the pocket with **(2) Phillips Screws** supplied. Skip to the Installation Instructions for ALL VEHICLES on Page #11.
