Pacific Accessory Corporation

VCI-GM1/AV

Video Camera Interface Kit for GM radios with Internal Navigation (for SUV's and trucks only)

INSTRUCTIONS

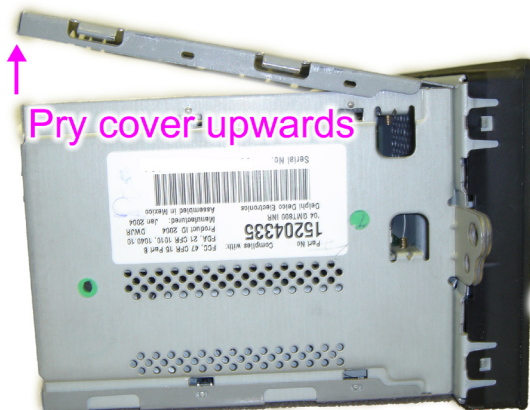
Step 1

Place factory radio upside down on flat surface. Remove bottom cover by prying from the back side of radio first.

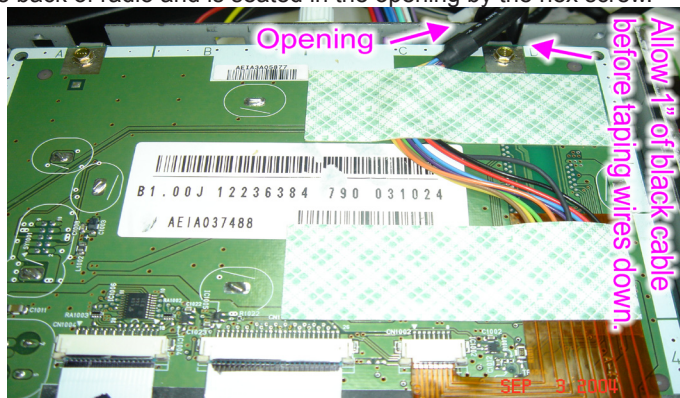
Step 5 Remove brown backing from white double stick tape and from ribbon cable. Apply ribbon to circuit board. Apply double stick tape on top of the colored wires towards back side of radio. Make sure the black insulated cable is about 1 inch inside of the back of radio and is seated in the opening by the hex screw.
