INSTALLATION INSTRUCTIONS FOR PART 99-5809

1998-2002 Lincoln Continental

99-5809

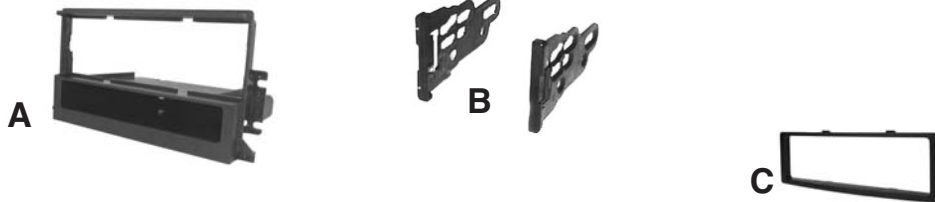
A) Radio Housing | B) ISO Brackets | C) ISO Trim Plate

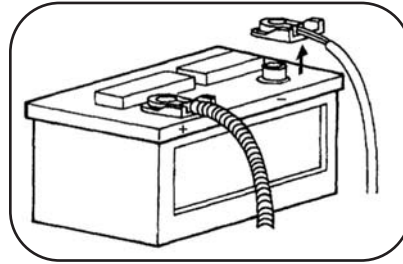
A

- 1** Disconnect the negative battery terminal to prevent an accidental short circuit.
(Figure A)
- 2** Remove (3) 9/32" screws from bottom edge of panel below steering wheel then unclip and remove panel. (Figure B)
- 3** Remove (1) 9/32" screw from left side of panel surrounding radio/climate controls then unclip and remove entire panel. (Figure C)
- 4** Remove (4) 9/32" screw securing radio. (Figure D)

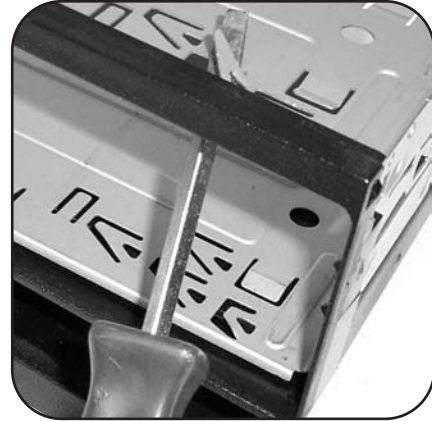
- 1** Slide the DIN cage into the Radio Housing and secure by bending the metal locking tabs down.
- 2** Slide the after-market head unit into the cage and secure.
- 3** Snap the Trim plate into the Radio Housing.

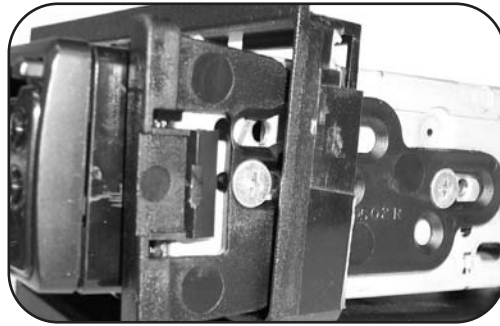
- 1** Mount the ISO Brackets to the head unit with the screws supplied with the unit.
- 2** Slide the head unit into the radio opening until the side clips engage.
- 3** Snap the Trim plate into the Radio Housing.

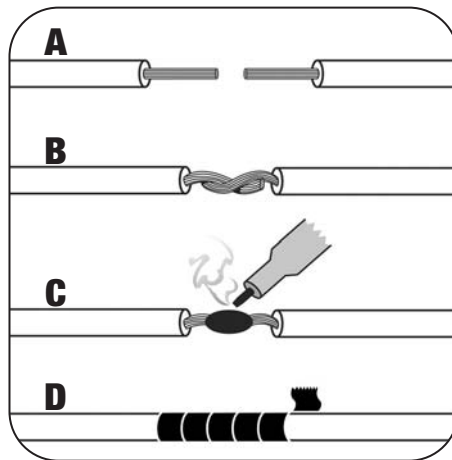
- A) Strip wire ends back 1/2"**
- B) Twist ends together**
- C) Solder**
- D) Tape**

- 1** Locate the factory wiring harness in the dash. Metra recommends using the proper mating adapter and making the connections as shown. (Isolate and individually tape off the ends of any unused wires to prevent electrical short circuit) See figure A.
- 2** Re-connect the negative battery terminal and test the unit for proper operation.
- 3** Reassemble radio and dash assemblies in reverse order of disassembly.
